**Maintaining, Renovating,  
Restoring and Preserving  
Historical Properties**

MARK STANIS  
DIRECTOR – CAPITAL CONSTRUCTION AND RENOVATIONS  
UVA FACILITIES MANAGEMENT  
MSTANIS@VIRGINIA.EDU

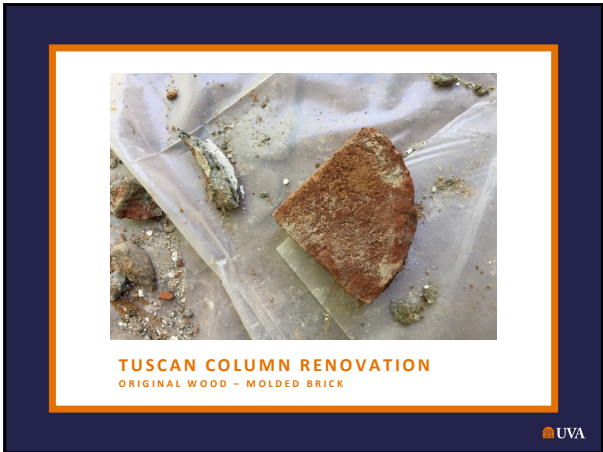
**TUSCAN COLUMN RENOVATION**  
ORIGINAL WOOD - MOLDED BRICK

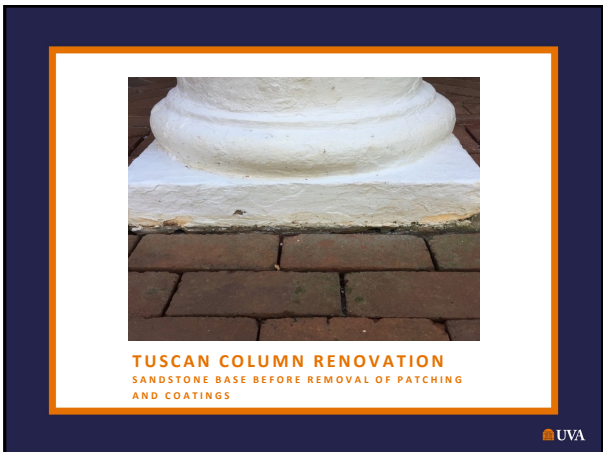
**TUSCAN COLUMN RENOVATION**  
SANDSTONE BASE BEFORE REMOVAL OF PATCHING  
AND COATINGS

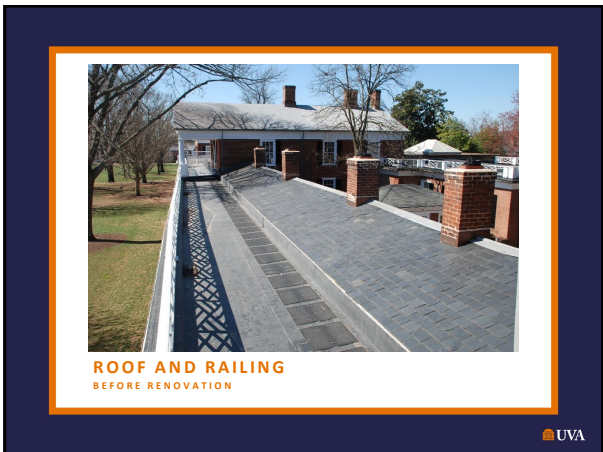
**ROOF AND RAILING**

BEFORE RENOVATION

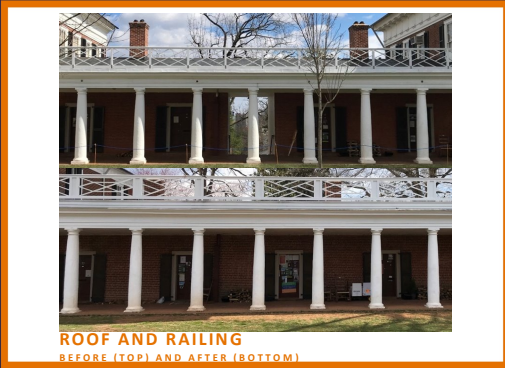
**ROOF AND RAILING**  
BEFORE (TOP) AND AFTER (BOTTOM)

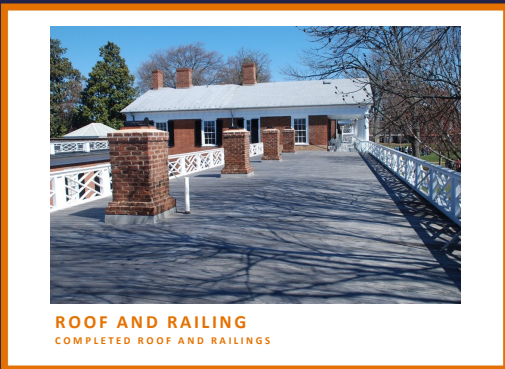
**ROOF AND RAILING**  
COMPLETED ROOF AND RAILINGS
